SSC-337

SHIP FRACTURE MECHANISMS INVESTIGATION

SHIP STRUCTURE COMMITTEE

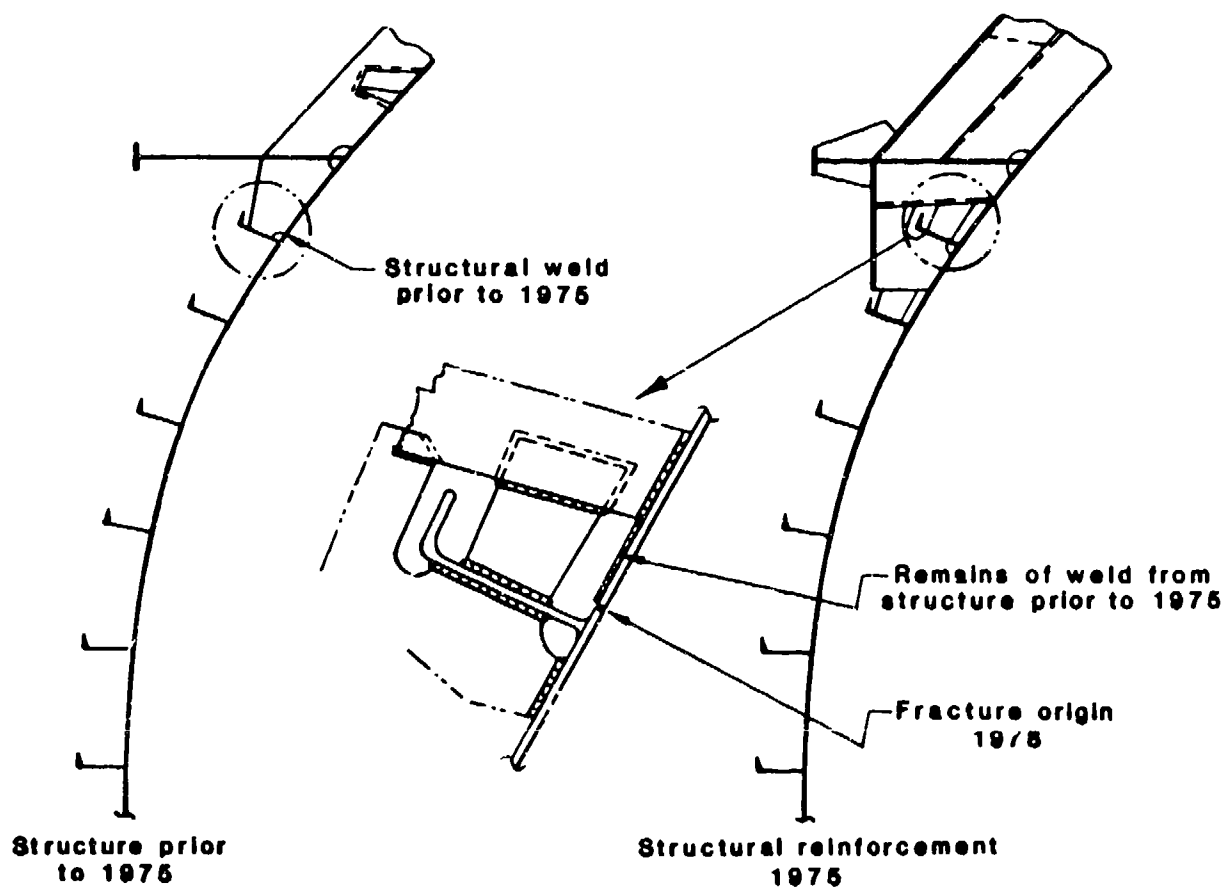
Figure 3-51 Structural Detail Associated With the Containership Bow Flare Fracture

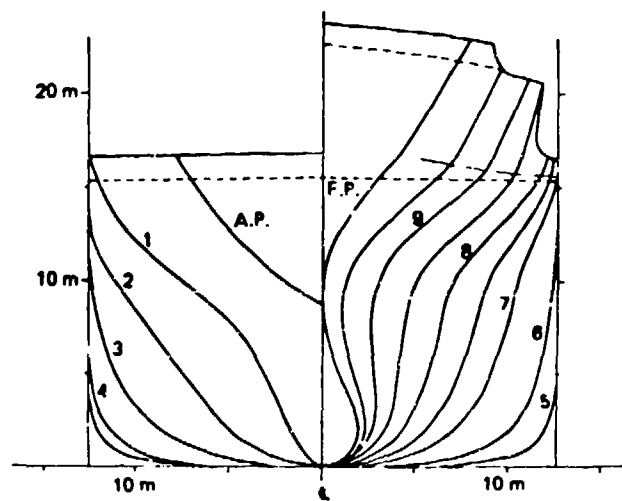
Figure 3-52 Body Plan of Containership

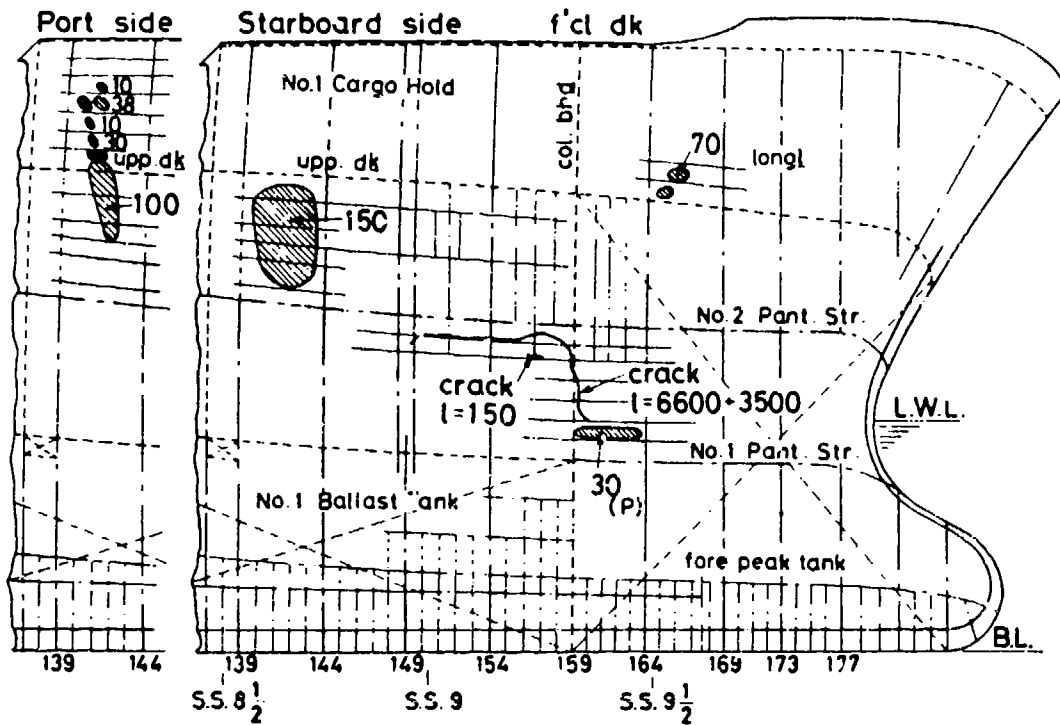
Figure 3-53 Shell Expansion and Fracture Location in the Containership Flare

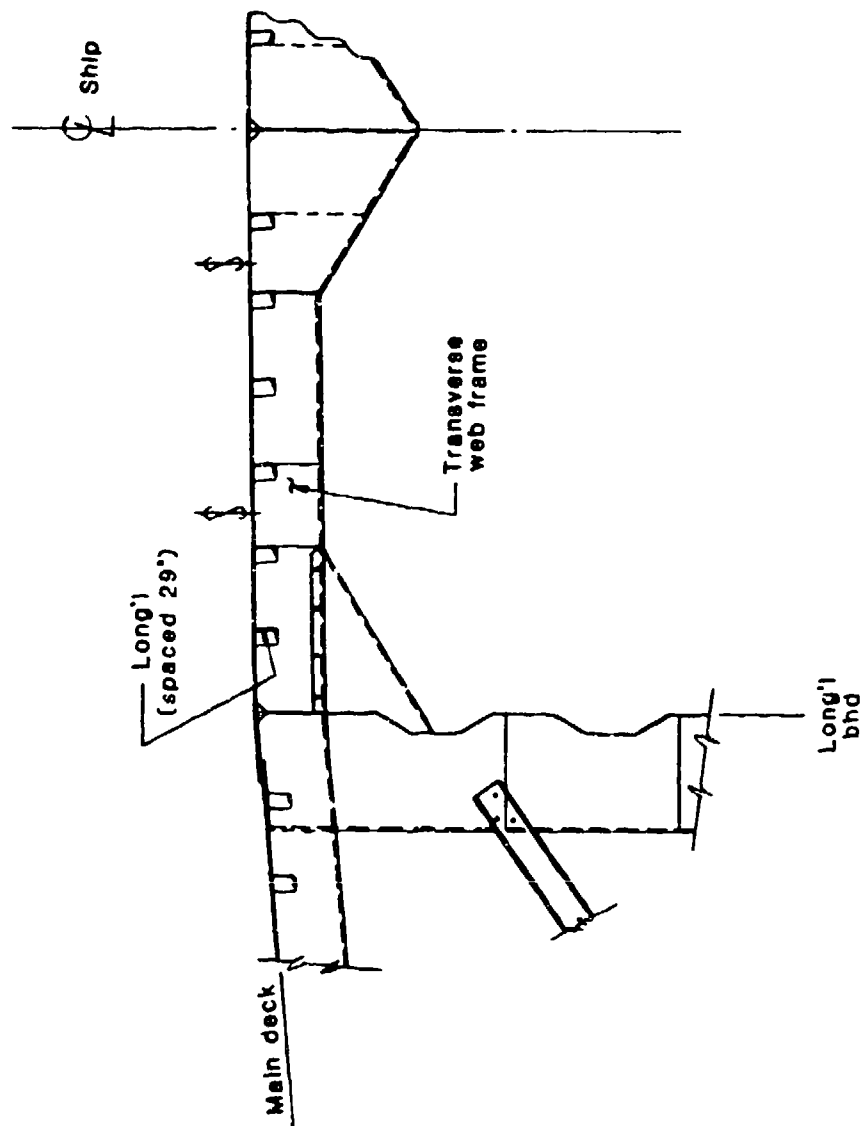
Figure 3-58 Structural Section of the Jumboized T-2 Tanker

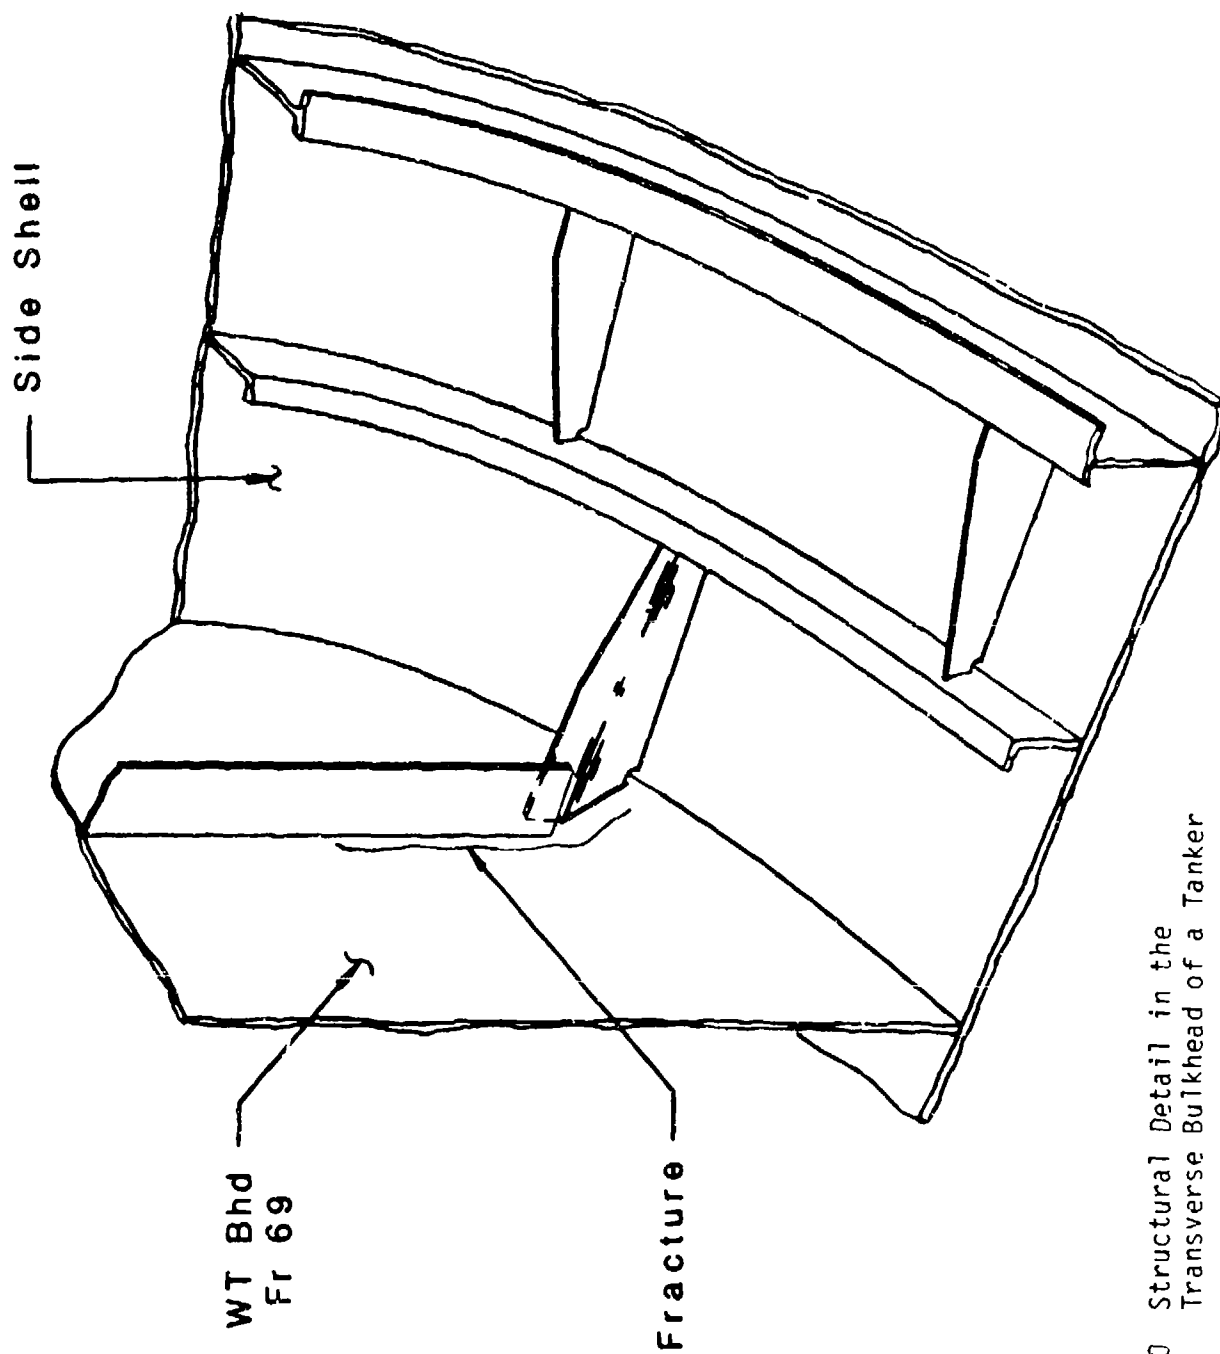
Figure 3-60 Structural Detail in the Transverse Bulkhead of a Tanker

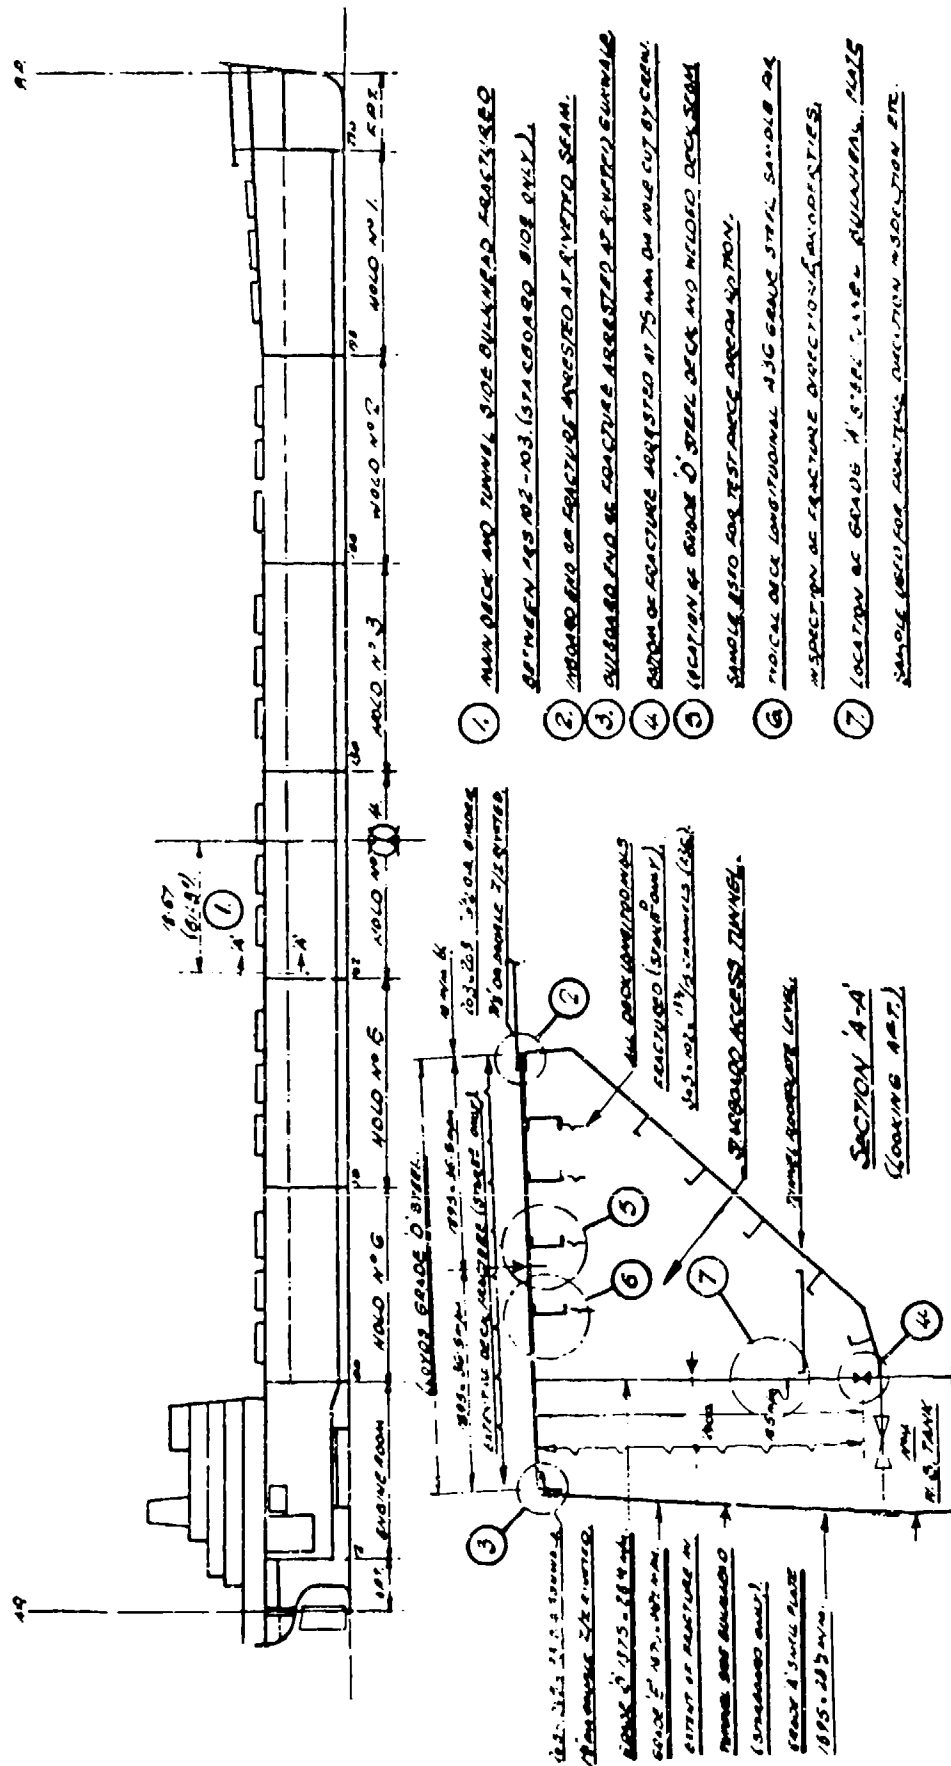
way. The main deck fracture was 12'-5" long and was located approximately 61'-0" aft of amidships. The main deck was .89" thick. A fracture was also discovered in the adjacent longitudinal bulkhead. Figure 3-62 shows the location of the fracture in a profile drawing and the transverse section of the structure in a detail drawing. An inspection of the main deck and longitudinal bulkhead fracture while afloat prior to drydocking revealed the following:

Figure 3-62 Profile and Structural Section of the Great Lakes Bulk Carrier Maindeck Fracture

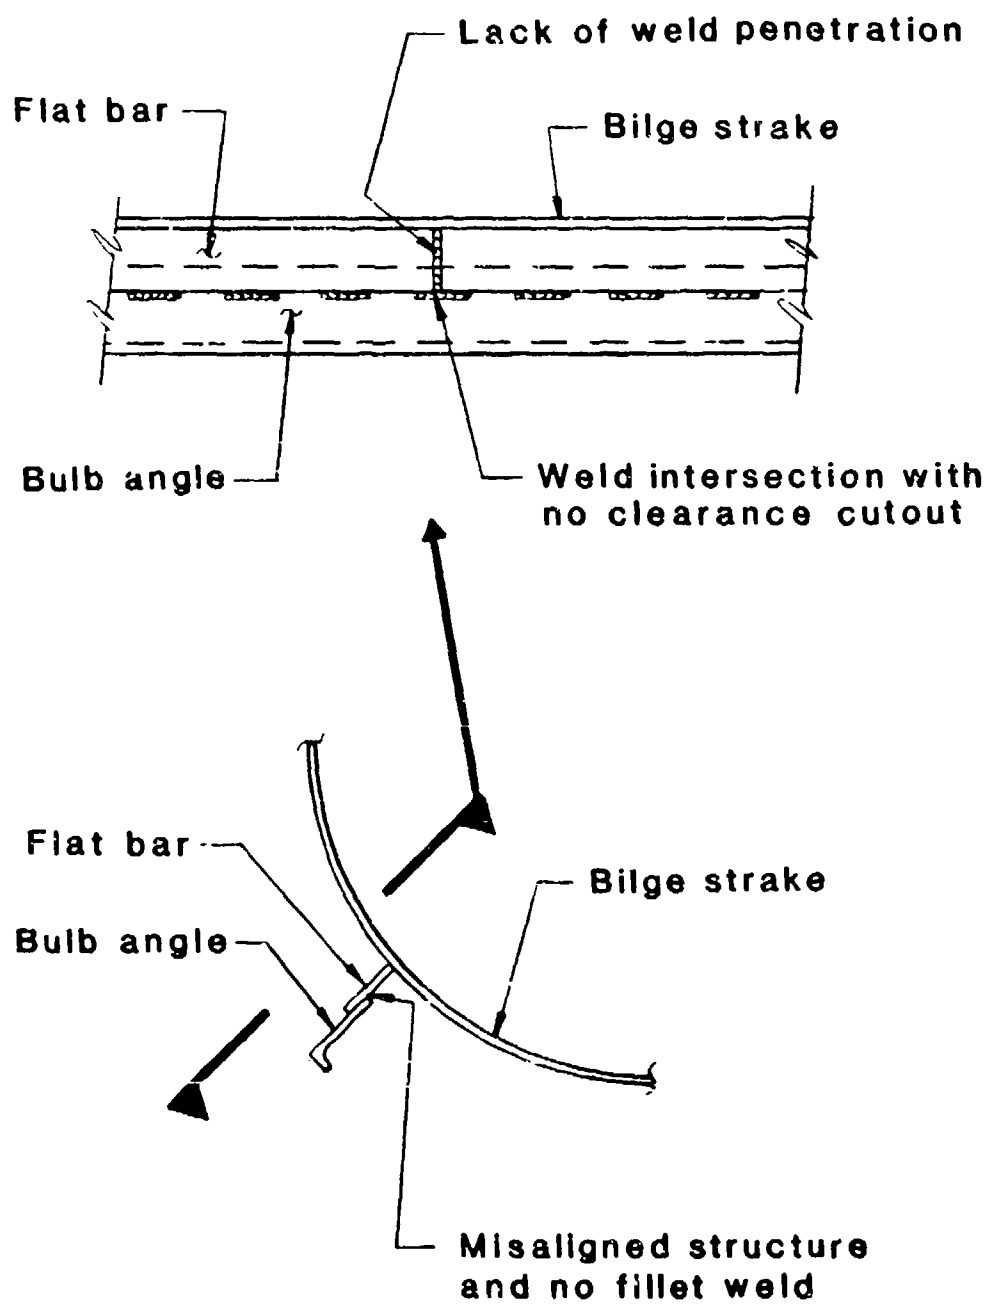
Examination of the fracture surface on the salvaged stern section revealed that although there were initiation sites on both the port and starboard sheer strakes. The most important fracture had initiated in the port bilge keel flat bar butt weld at Frame 171. The weld showed a lack of penetration and no sign of a weld cutout at the side shell. The bilge keel detail is illustrated in Figure 3-64. After inspection of the fracture origin, it was learned that the bilge keel was damaged forward of Frame 171 from grounding and repaired at a drydocking prior to the fracture occurrence. It was apparent from the presence of the characteristic chevron markings that the fracture had occurred in a brittle manner and propagated from the butt weld across the bottom of the ship to the starboard bilge keel at Frame 174 and vertically up the port and starboard side. Many of the longitudinals had also failed in a brittle manner.

Figure 3-64 Bilge Strake Detail of the Tanker Hull Failure

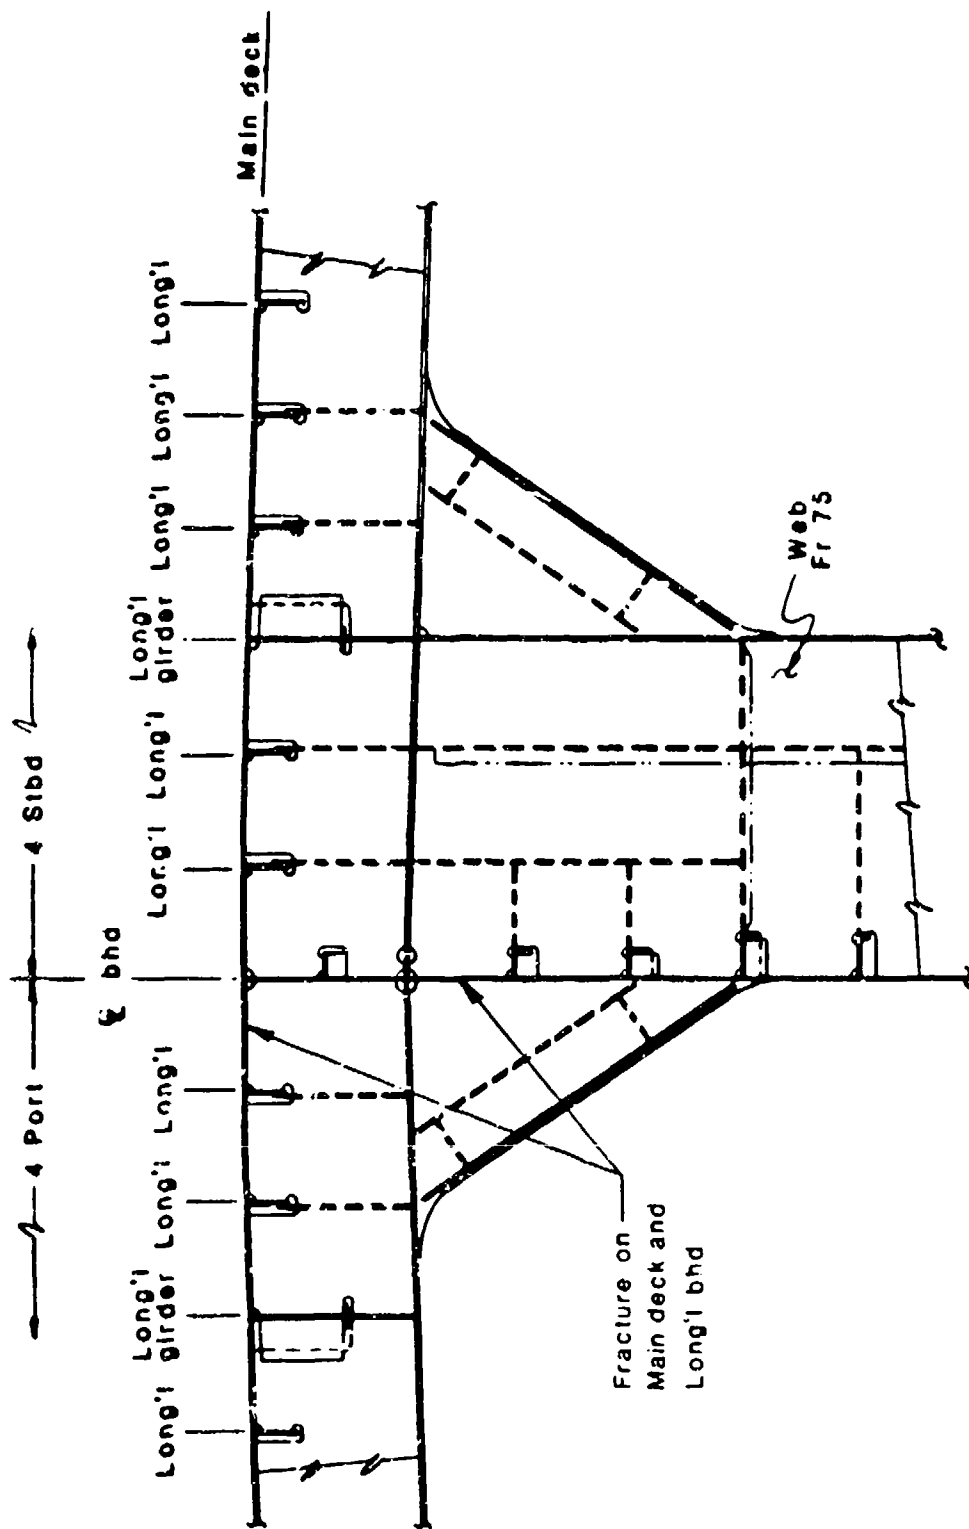
Figure 3-65 Structure of the Tanker With a Longitudinal Bulkhead Fracture

The fracture was located in a longitudinal bulkhead and main deck two feet aft of Frame 75. The location of the fracture and surrounding structures are illustrated in Figure 3-65. The steel in the vicinity of the fracture was ABS DH36 .75" thick.

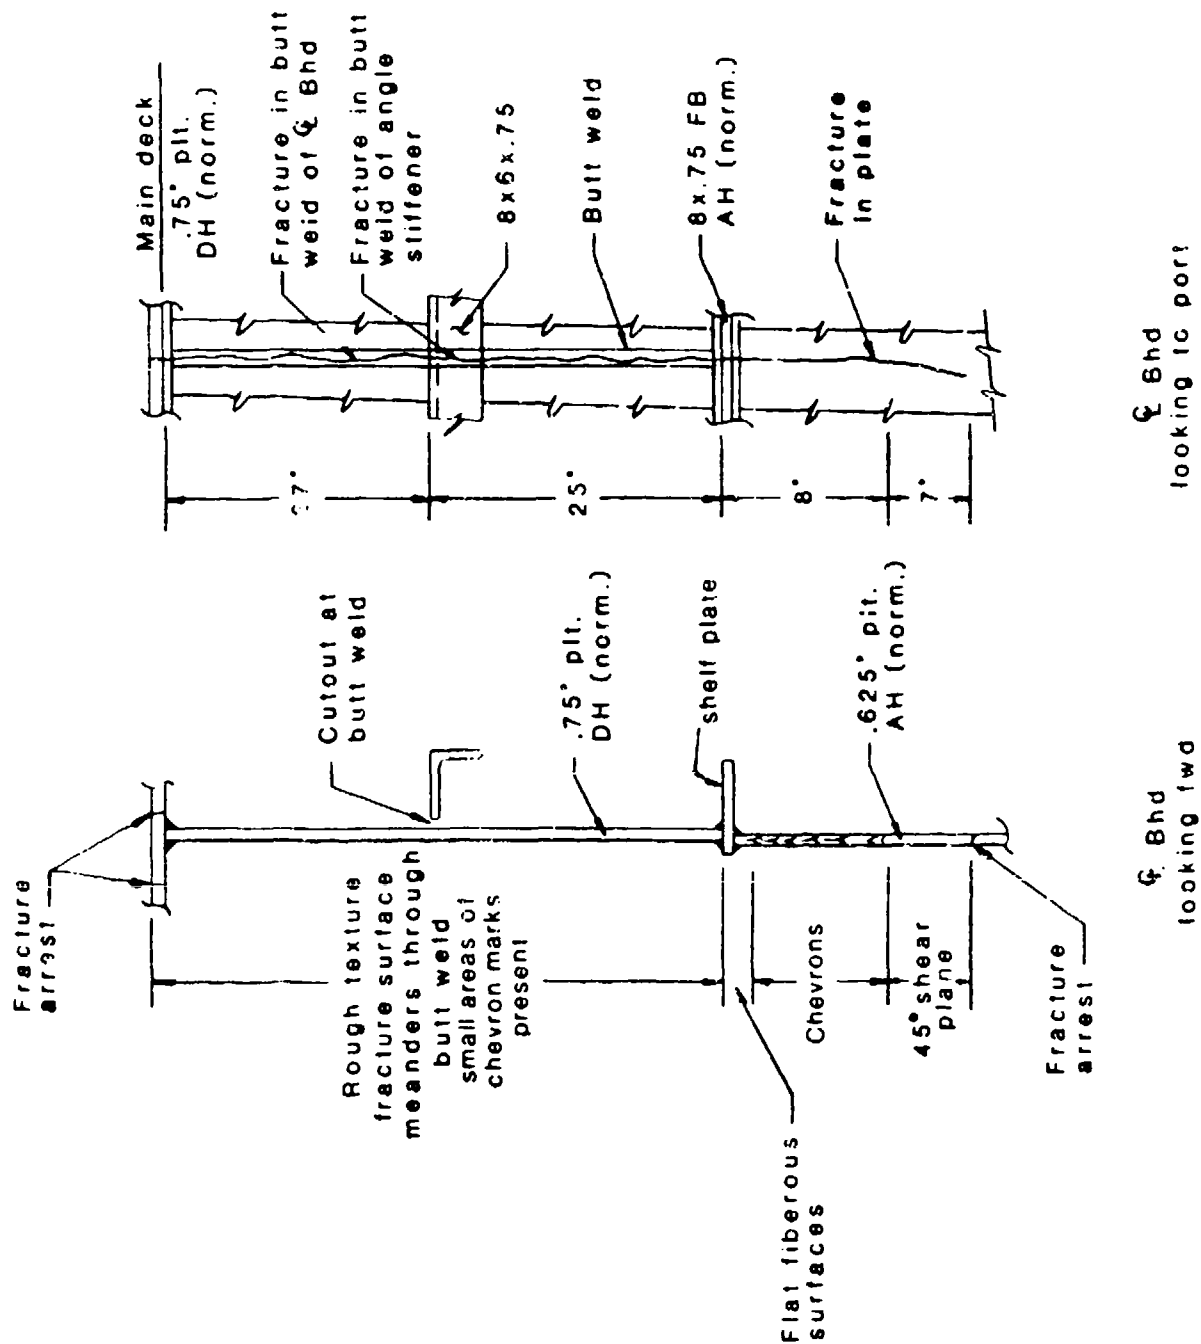
Figure 3-68 Key Illustration of the Longitudinal Bulkhead Fracture

The entire fracture was removed for further examination and fractographic analysis at Lehigh University. Visual examination of the fracture surface revealed that the fracture surface was caused by fatigue above a longitudinal shelf and brittle fracture below as shown in Figures 3-66, 3-67, and 3-68.

The project investigators believe that the fracture initiated by fatigue along the toe of a butt weld in the bulkhead, probably at several places, and progressed along the seam by both fatigue and brittle fracture. A clear brittle fracture region occurs in the bulkhead below the longitudinal shelf plate. The

brittle fracture progressed across the transverse shelf plate and downwards through the bulkhead where it terminated as a shear fracture. There was no evidence of significant defective welding. The fracture in the deck was a result of fatigue crack growth from the initial crack in the bulkhead. The investigation indicated that the fracture propagated in a region of suspected high local residual stress caused during the welding of the deck subassemblies.

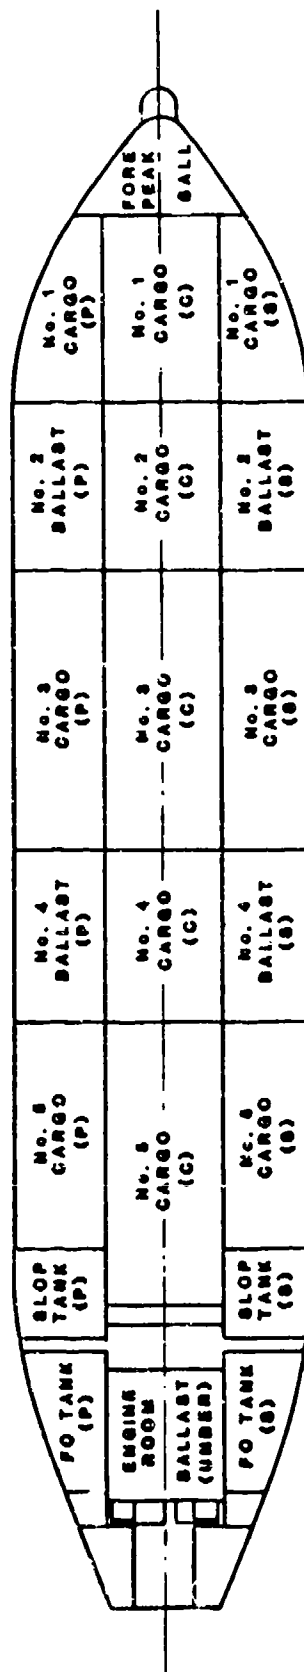
Figure 3-70 Cargo Hold Plan of the 173,000 DWT Tanker

A cargo tank arrangement drawing is shown in Figure 3-70. All main deck plate, with the exception of the outboard deck strakes port and starboard, is AH36. The outboard strakes on the main deck are DH36. The sheer strakes, bilge, and flat keel are DH36. All other structure is AH36.

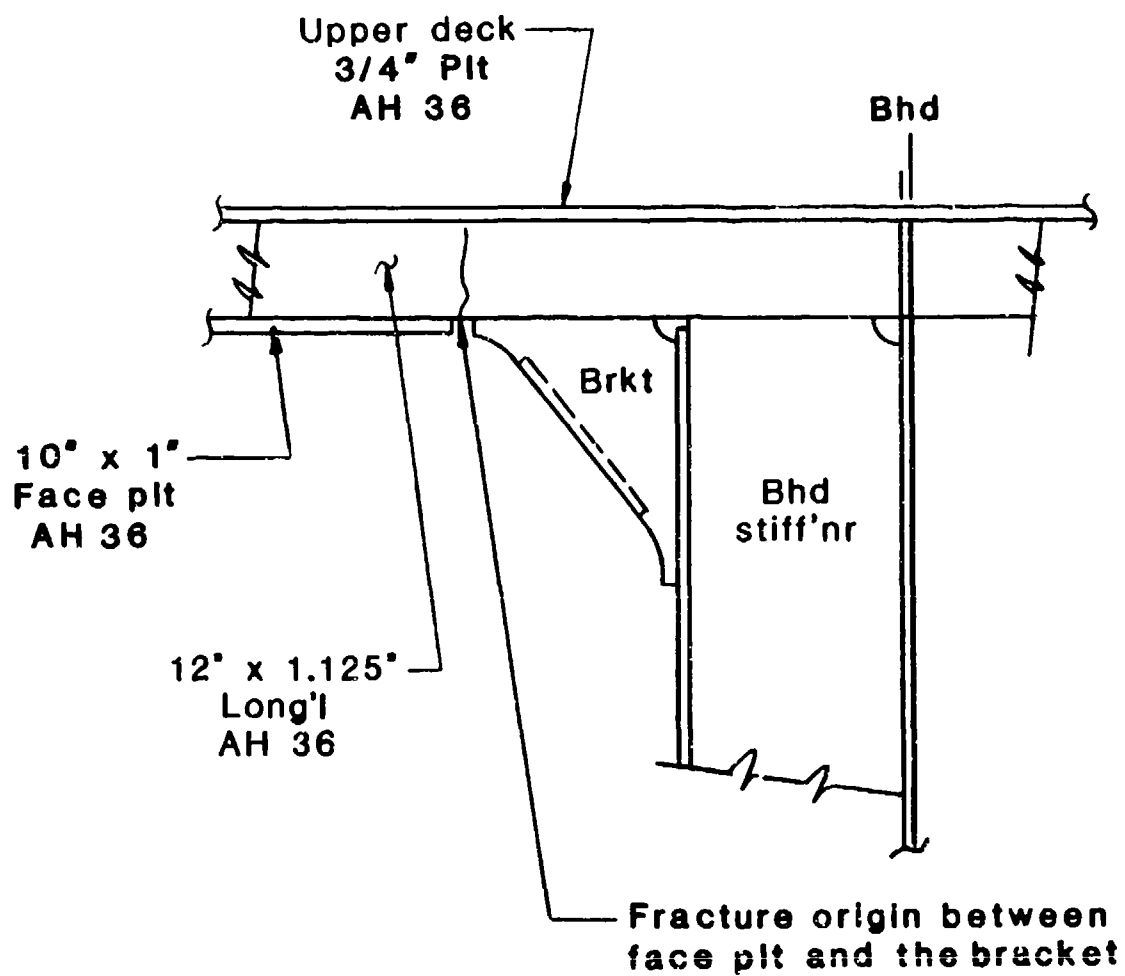
Figure 3-71 Structural Detail at the Origin of the Fracture in the 173,000 DWT Tanker

The apparent point of origin is at a notch in the underdeck longitudinals between the longitudinals and a bracket in the transverse web frame as shown in Figure 3-71. Fatigue propagation was observed in the longitudinal fractures.

The fracture reportedly terminated at EH Grade steel arrestor strakes .
